**Flood Control Project Maintenance  
Levee Inspections**

**Maintenance Issue Types Only, Levee Inspection Report By Mile - Spring 2019**

**Reclamation District No. 2107 Mossdale Island**

Waterway	Bank	Unit Miles	Inspection Start/End	Inspector
Unit No. 01 San Joaquin River	Left	2.33	05/10/2019 05/10/2019	Alberto De Leon

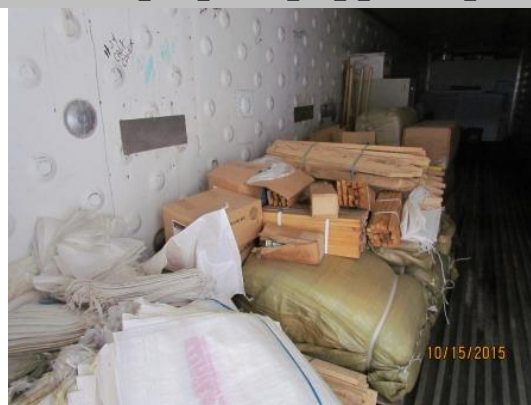
Photo 1 of 1 : SP\_2019\_RD2107\_329\_7\_20190313\_00001.jpg

LM Start		Rating **	A	Issue No.	7
LM End		Issue Type +	Ma	Location *	
Category	Earthen Levee		GPS Latitude/Longitude		
			Start	End	
Item	Emergency Supplies & Equipment				
DWR ID	DWR_RD2107_01_s_2013_7				
Comment Code					
Inspector Comment					
Flood fighting supplies are available on-site.

View of the flood fight emergency supplies.

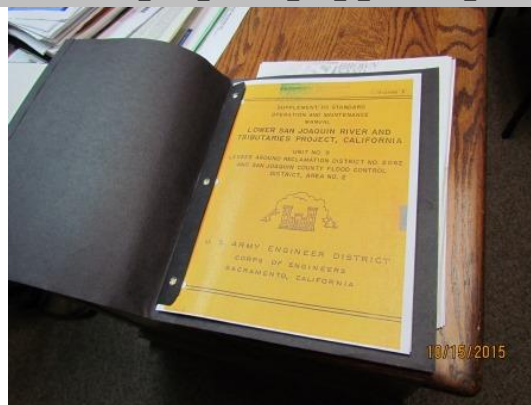
Photo 1 of 1 : SP\_2019\_RD2107\_329\_8\_20190313\_00002.jpg

LM Start		Rating **	A	Issue No.	8
LM End		Issue Type +	Ma	Location *	
Category	Earthen Levee		GPS Latitude/Longitude		
			Start	End	
Item	Operations & Maintenance Manuals				
DWR ID	DWR_RD2107_01_s_2013_8				
Comment Code					
Inspector Comment					
The O&M Manual is available at the LMA's office.

View of the O&amp;M Manual.

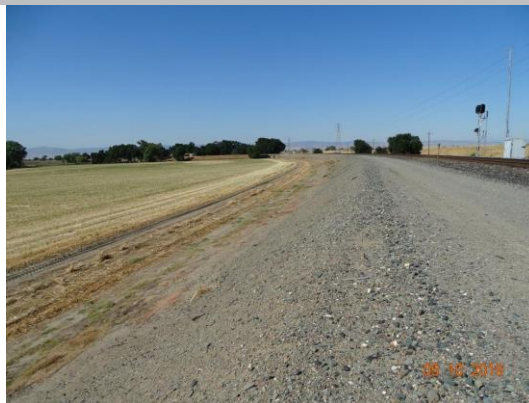
Photo 1 of 1 : SP\_2019\_RD2107\_329\_22\_20190514\_00025.jpg

LM Start	0.23	Rating **	A	Issue No.	22
LM End	2.04	Issue Type +	Ma	Location *	LS
Category	Earthen Levee			GPS Latitude/Longitude	
				Start	End
Item	Vegetation			37.784586 °	37.765040 °
				-121.306837 °	-121.309750 °
DWR ID	DWR_RD2107_01_s_2019_22				
Comment Code					
V1 : Control annual grass and weeds on the levee slopes and easements.					
Inspector Comment					
Annual vegetation is well maintained.

Typical view of vegetation on landside slope. (Spring 2019)

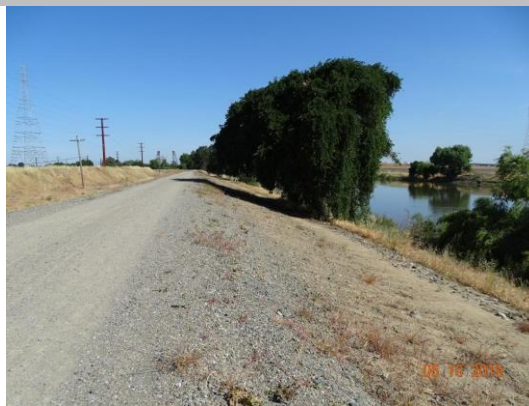
Photo 1 of 1 : SP\_2019\_RD2107\_329\_23\_20190514\_00026.jpg

LM Start	0.23	Rating **	A	Issue No.	23
LM End	2.04	Issue Type +	Ma	Location *	WS
Category	Earthen Levee			GPS Latitude/Longitude	
				Start	End
Item	Vegetation			37.784586 °	37.765040 °
				-121.306837 °	-121.309750 °
DWR ID	DWR_RD2107_01_s_2019_23				
Comment Code					
V1 : Control annual grass and weeds on the levee slopes and easements.					
Inspector Comment					
Annual vegetation is well maintained.

Typical view of vegetation on waterside slope. (Spring 2019)
